Practical Applications of Cables and Ropes in the ISS Countermeasures System

Abstract—National Aeronautics and Space Administration (NASA) uses exercise countermeasures on the International Space Station (ISS) to maintain crew health and combat the negative effects of long-duration spaceflight on the human body. Most ISS exercise countermeasures system (CMS) equipment rely heavily on the use of textile and wire ropes to transmit resistive loads and provide stability in a microgravity environment. For a variety of reasons, including challenges in simulating microgravity environments for testing and limits on time available for life cycle testing, the textiles and wire ropes have contributed significantly to on-orbit planned and unplanned maintenance time. As a result, continued ground testing and on-orbit experience since the first expedition on the ISS in 2000 provide valuable data and lessons learned in materials selection, applications, and design techniques to increase service life of these ropes.

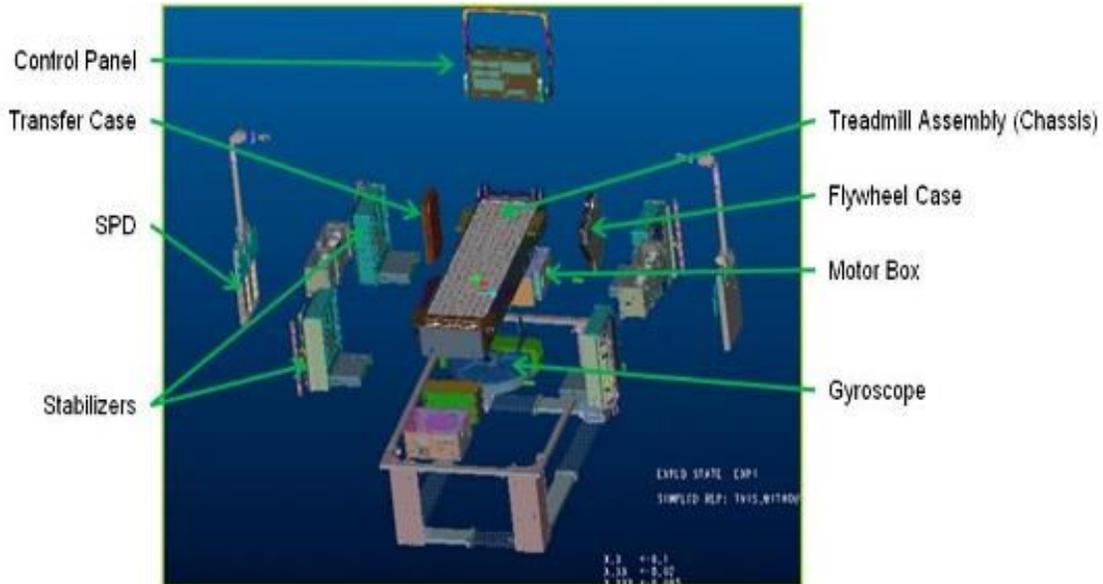
Figure 1. TVIS System

stabilizers, four motor controllers and a VIS controller. The running surface of the treadmill was used in much the same way as any conventional terrestrial treadmill, except the user was held to its surface by the Series Bungee System (SBS) and/or the Subject Load Device (SLD), which each attached to the Treadmill Harness to counter the microgravity environment. TVIS served on ISS until 2013, at which time it was replaced with the Russian BD-2 treadmill [2]. Figure 1 shows a schematic of the TVIS, while Figure 2 shows the TVIS in use on ISS, including the SBS.

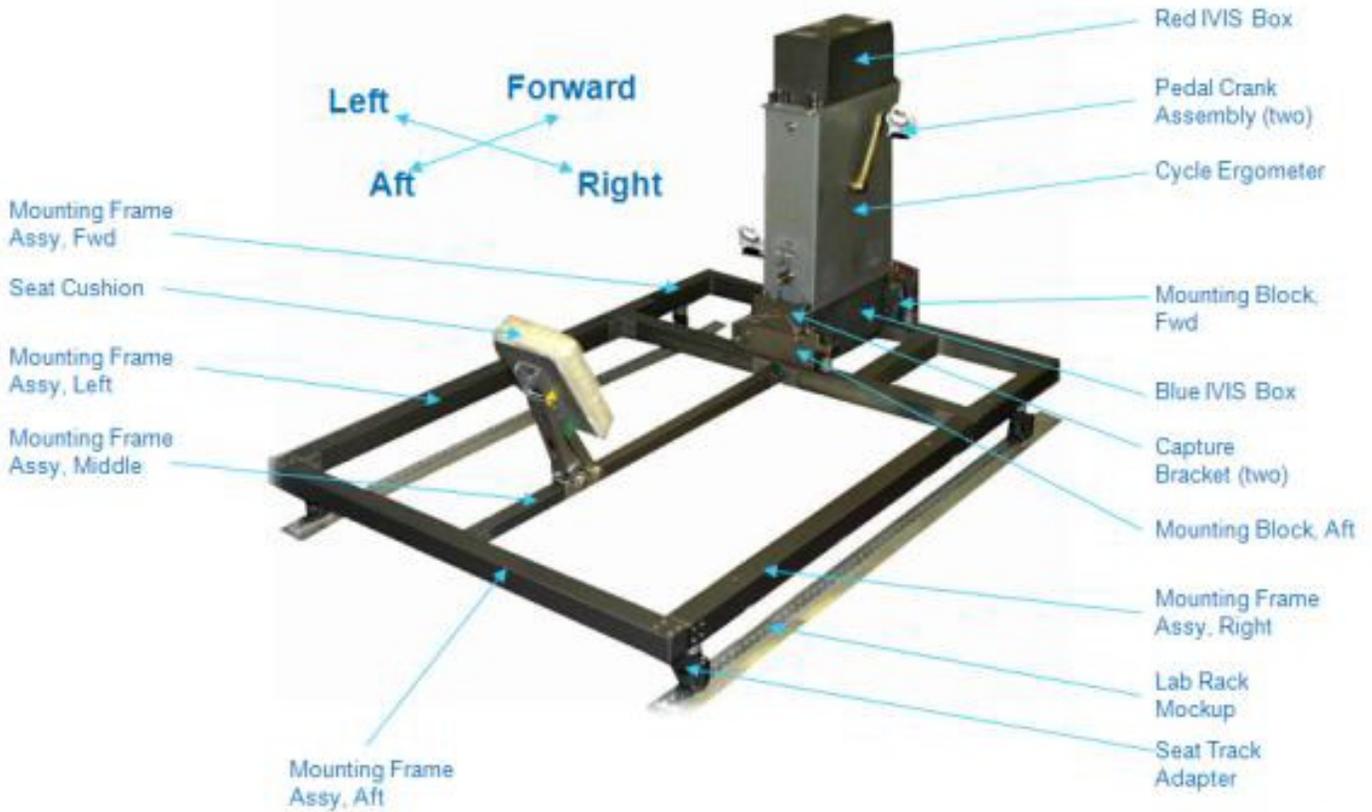
Figure 3. CEVIS System

While the TVIS provides the ability to run or walk in microgravity, the CEVIS system provides cycling aerobic exercise, in either a recumbent or upright posture. CEVIS is also used for pre-breathe operations prior to an Extravehicular Activity (EVA), periodic fitness evaluations, and pre-landing fitness evaluations. The CEVIS Ergometer can be controlled electronically via protocols in a control panel, or it can be manually controlled by the subject. The Control Panel displays real-time subject data, including heart

rate, speed, and workload. Two Inertial Vibration Isolation and Stabilization Boxes are attached at either end of the Ergometer and provide passive mechanical counter-inertia to the forces imparted by the riding subject. These minimize the forces imparted into the CEVIS frame and hence into the ISS structure via wire rope isolators located in each of the four corners. CEVIS was deployed on ISS in March 2001 and continues to be in service. Figures 3 and 4 shows the CEVIS schematic and the CEVIS in use in an upright posture, respectively [3].

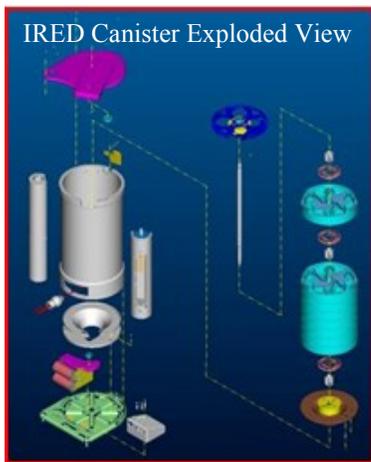
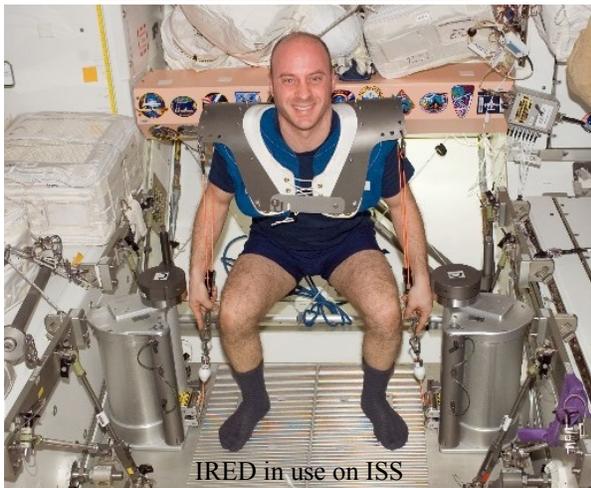
Figure 5. IRED figures

Aerobic exercise is one powerful countermeasure to microgravity effects, but additionally, resistive exercises are needed to prevent both muscle and skeletal atrophy. To provide ISS astronauts an interim resistive exercise capability, the IRED was developed and was in service from May 2000 until ARED was installed in January 2009. It had a capability of 320 pounds of resistive load using two canisters. The canisters contained rubber spring flexpacks, which when rotated about a center shaft, provided resistive load to the user via a rope and pulley system. The load adjustment was created by turning a hand crank and preloading the flexpack stack to the desired load. IRED did not contain vibration isolation features or a capability to record data to verify device performance. Figure 5 shows the elements in the canister used to provide resistance as well as the IRED in use [4].

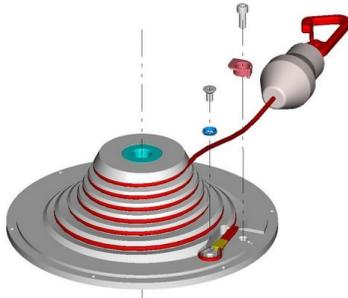
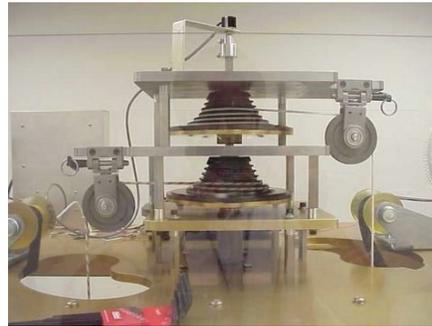
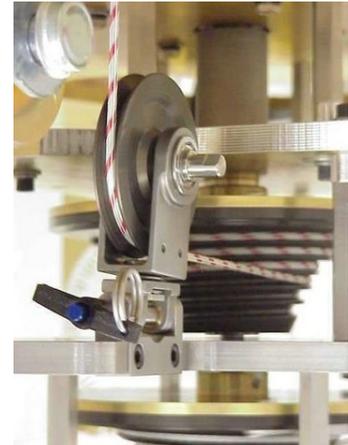
Figure 7. IRED spiral pulley with cord and life cycle testing support equipment

ARED—The design for IRED included a spiral outlet pulley to counter the spring constant and provide uniform load, which required a strong, durable, and lightweight cable. Several materials were considered, but the need to have a low-stretch cord focused the search to a few polymer rope options. With Johnson Space Center (JSC) located close to Galveston Bay and the Gulf of Mexico, the sail rigging shops in close proximity became an advantage to the IRED team, as the mechanics of the canister and cord were similar to the rigging of a sailboat. The technicians in the sailing shops were not only familiar with the material properties of certain cords, but they also knew which ones were more durable and best fit the application of the IRED. They shared their knowledge on rope splices and eyelets, proper needle selection for stitching, and whipping techniques to make the cords streamlined and durable. After consulting with the sailing riggers, two candidate cord materials were recommended for evaluation. The first, made of 1/8 inch AracomT®, was tested in the IRED cord life-cycle test rig. This rig consisted of two spiral pulleys, wound with cords attached to bags of lead shot weighing 150 pounds each. This allowed two cords to be tested at a time. The IRED pulleys were coated with Poly-Lube® to prevent corrosion and provide a slick surface, preventing wear and binding on the

ropes. The AracomT cord broke at only 6,930 cycles, which was less than a week of cycles for three ISS crewmembers, well below the acceptable threshold of service life. The next cord tested was made of 1/8 inch Edelrid Dyneema®, and it broke at 214,060 cycles, which using a scatter factor of 4, allowed it to be certified to 53,515 cycles with 2-week inspections for damage. (Note: the structural analysis community typically recommends a scatter factor of 4 for structure/safety-critical applications, and a factor of 2 for

non-structure/non-safety critical applications). This would allow each cord to be used for approximately 3 months on orbit before replacement would be required, dependent upon the number of crewmembers and their daily usage rate. This was acceptable to the ISS Program, and this cord was selected for the IRED flight design. Figure 7 shows a diagram of the IRED Spiral Cord Pulley along with the cord life cycle test equipment. [6,7]

Failures of the IRED canister cords led to slight evolutions in the design and insight into how to conduct verifications. A Dyneema cord broke early in the IRED life-cycle testing, raising doubt about the robustness of the design. Confidence was restored when a burr was discovered on a spiral pulley that had been installed into the test rig, which resulted in accelerated erosion to the cord sheath over a short time. Had this pulley been properly inspected, the cord would have reached its expected life. Another failure mode involved premature breaking during proof load testing for a certain batch of canister cords. An investigation uncovered that the number of stitches inserted into splice at the terminal end of the cords was out of specification and that too many splice stitches weakened the cords. The drawing and fabrication procedures were updated to tighten the tolerance on the number of splice stitches, and subsequent batches of cords never experienced this failure again [8,9,10].

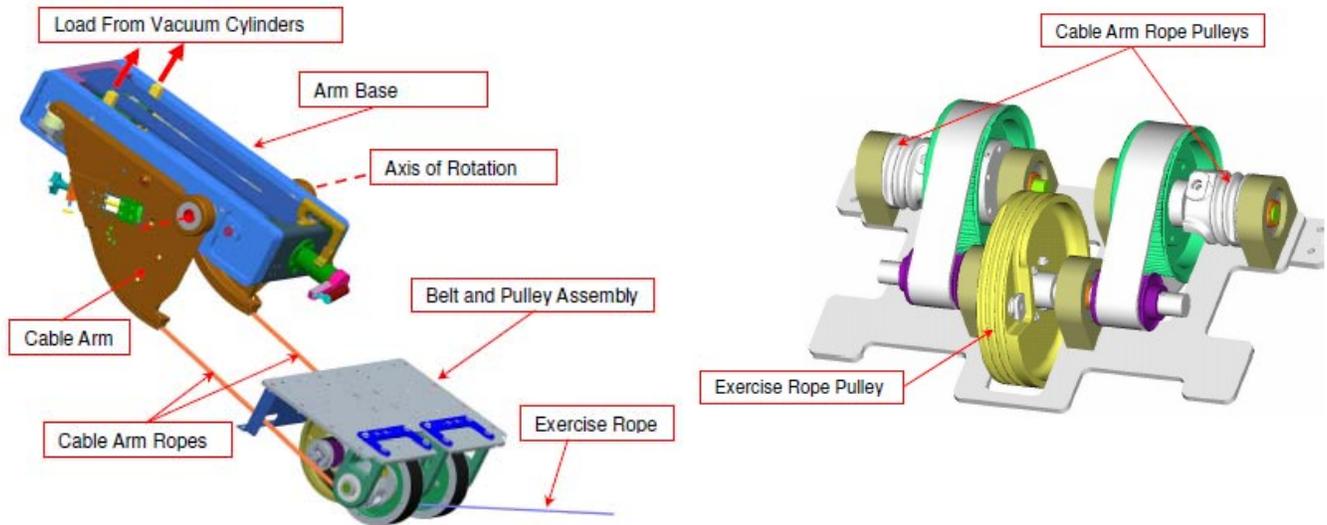
Figure 8. ARED rope and pulley system

a. *Workload Ropes*—The ARED uses two different types of ropes to achieve workload for the user during cable exercises, the cable arm ropes and the exercise rope. The load on the cable arm ropes is provided by the resistance of the vacuum cylinders through the cable arm and is transmitted to the exercise rope through a series of pulleys and belts. The cable exercise system was designed so that the two cable arm ropes experience a higher load than the exercise rope. The cable arm rope pulleys have a conical profile that the rope winds around. This design mitigates the effective change in length of the cable arm moment arm as it moves through its stroke, which, in turn, maintains a constant load on the exercise rope. The pulleys in the ARED are coated with TUFRAM® to prevent corrosion and provide a slick surface, preventing wear and binding on the ropes. The ropes utilize splicing where the fibers are woven into themselves, creating a friction retention that tightens as forces are applied. Figure 8 shows the ARED rope and pulley system.

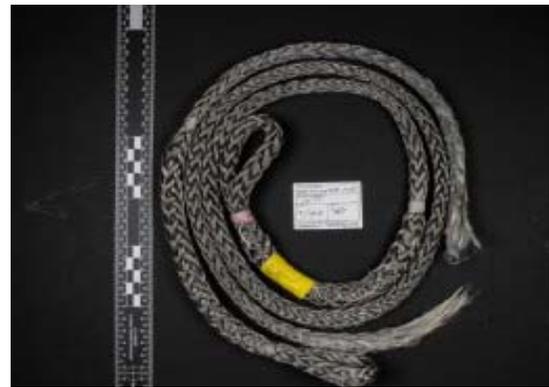
Figure 9. Failed ARED cable arm rope

The life-cycle testing was conducted on 3/8 inch diameter cable arm ropes and yielded a failure of 138,612 cycles. The 80-inch ropes had breakage about 24 inches from the end near the cam pulley. A broken Vectran rope was submitted to JSC Materials and Process Branch for failure analysis, and the analysis concluded that the failure was caused by flex fatigue and abrasion from the pulleys during the life-cycle testing. Based on the test results and lower stretch characteristics, the Vectran cable arm ropes were certified using a scatter factor of 2 for 69,306 cycles, which was initially projected to last greater than 6 months for 3 crewmembers. Subsequently, the actual consumption rate was higher, so they currently last approximately 3-4 months for 6 crewmembers. Figure 9 provides a photograph of a failed Vectran ARED cable arm rope after initial life cycle testing.

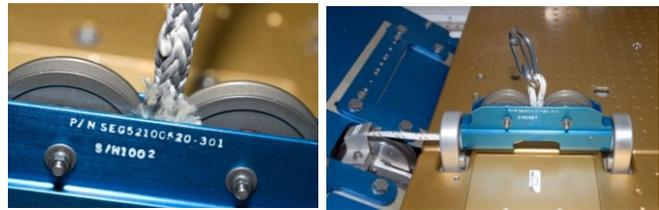
Failures of the ARED workload rope led to two improvements in the design. The first failure occurred in the Vectran exercise rope design on ISS. As the rope was cycled over time through the outlet pulleys, the splice grew in diameter due to end (tail) of the rope working its way back through the braid. This caused the splice to wedge in the pulleys and added tension to the system, which caused the cable arms to pop out of the detents during bar exercise. This was corrected by loosening the tension on the cable arm ropes and allowing the exercise rope splice to no longer retract into the pulleys. This issue, along with the short life of the Vectran exercise rope, helped justify the new polyester exercise rope redesign. The second failure of an exercise rope occurred on ISS with the polyester rope. In January 2012 the crew was exercising and noticed that the splice had come apart, rendering the rope unusable. This condition was never observed on the ground during testing, but the possibility of manual manipulation during zero-load conditions of the splice could have caused the splice to come apart, as without load on the rope, the fibers tend to loosen slightly. Based on this failure, the ISS Program and the CMS team decided to stand down on use of the polyester rope on orbit and install the Vectran rope as an interim workaround. After a redesign effort, including consulting with the rope supplier, the team decided to add a lock stitch to the rope splice in order to prevent the splice from coming apart during zero-load conditions. After the design was fabricated, the life cycle test was reinitiated with the new rope design and certified to the same cycle count as the previous polyester rope design (242,717 cycles). The updated polyester rope design was installed on orbit in September 2014 and continues in use currently. The life cycle test continues currently, and as of August 2015, the rope was certified for 481,958 cycles, which equates to approximately 2 years of operational life. Figure 10 provides several images of ARED exercise rope designs and related failures. [12,13]

Vectran rope wedged in pulley (left); polyester rope installed (right)

Figure 10. ARED exercise rope designs and related failures

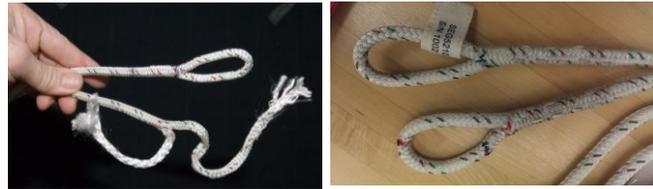
Polyester rope splice pull-out (left); polyester rope with lock stitch (right)

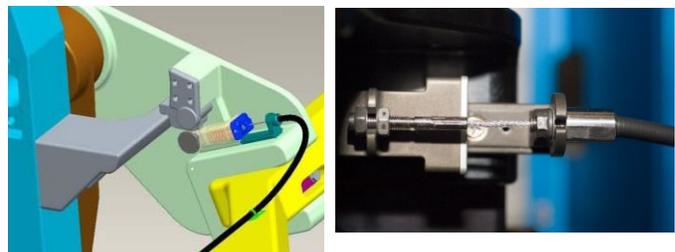
Figure 11. ARED upper stop actuator cable mechanism

b. *Upper Stop Cable*—The second type of ARED rope failure was in the upper stop cable. The ARED bar contains a mechanism that allows it to latch into an upper position in order to perform exercises that begin in a standing position, such as squats and heel raises. A spring actuated pawl swings and latches against a plate fastened to the ARED frame. The crewmember actuates the upper stop mechanism by lifting the bar and changing the angle between the main arm section and the vertical adjustable lift bar slides. The sliding linkage, including the upper stop cable made of Teflon®-coated 1/8 inch wire rope, provides the means for the crewmember to release the pawl by changing the angle of the lift bar and the main arm. Figure 11 shows the ARED upper stop actuator cable mechanism [5].

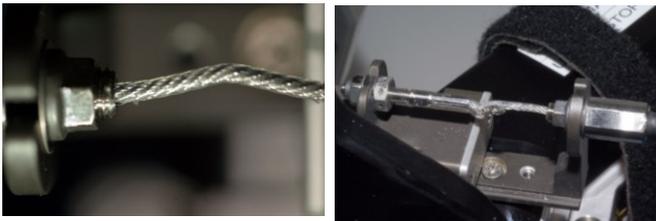
Figure 12. ISS ARED upper stop cable failures

The upper stop cable has been an area of multiple failures since ARED was put into service in 2009. The failure typically begins as a bent or kinked cable and progresses to a broken or frayed cable, halting all exercises performed from the upper stops. This problem had a history of occurring approximately every 2 years, requiring the cables be replaced with new units, but in late 2014 into early 2015, a series of rapid-succession failures occurred on the upper stop cables on both the left and right sides. This initiated a root-cause investigation, and it was concluded that the mechanics of the mechanism applies a push force on every repetition of bar

exercise as the pawl follows the bottom edge of the upper stop plate. However, the forces applied to the upper stop cables were never intended to be push forces. They were only intended to operate in tension. The fatigue resulting from the cycling of this push force eventually causes a kink in the cable, which erodes the Teflon sheath on the cable housing, and eventually causes it to fray or break, halting upper stop exercises until it can be replaced. As a result of the findings, the crew was requested to increase their frequency of inspections, and the engineering team launched additional spares to ISS. A redesign of the upper stop mechanism to eliminate the push forces could be an option, and life-cycle testing could be used to compare the life of the old and new designs. (Note: There was no life cycle testing performed on the upper stop hardware) ARED Upper Stop Cable Failures on ISS are depicted in Figure 12 [14,15].

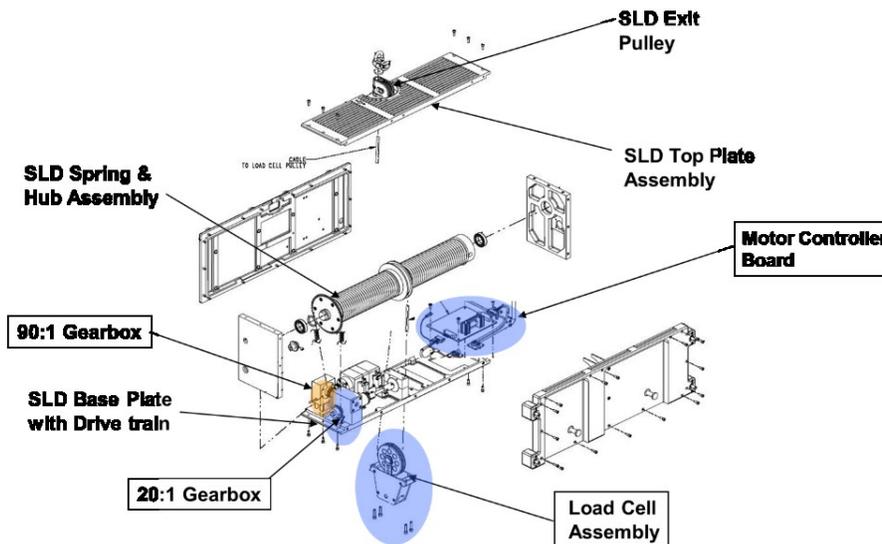
Figure 13. TVIS SLD – exploded view

TVIS SLDs—The TVIS SLDs were the primary subject restraint system hardware and were attached to the sides of the treadmill chassis. Prior to exercise, the crewmember would don the TVIS harness, clip the harness y-straps or attach the SBS to the respective end stops on the SLD’s cables. The SLD pair provided loading from 40 to 220 pounds, adjustable via control panel entry or protocol. Each SLD was instrumented with a load cell, which measured tension in the cable attached to the subject. The load variation of the SLD is approximately 6 lb/in. of cable extension. In the initial SLD design the cable exited the SLD housing at the top plate from a non-fleeting, fixed position exit pulley. Due to failures discussed in the subsequent section, the pulley was upgraded to fleeting pulley in 2005 due to varying cable angles produced by crewmembers not using the TVIS Subject Positioning Devices (SPDs). The cables on the SLDs were 1/8 inch galvanized steel cable with a nylon sheath. Figure 13 shows an exploded view of the TVIS SLD [2].

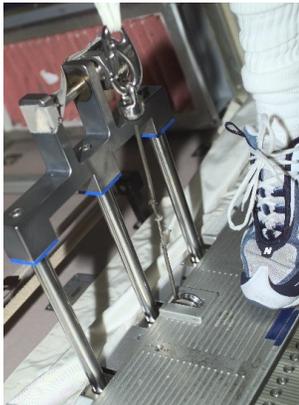
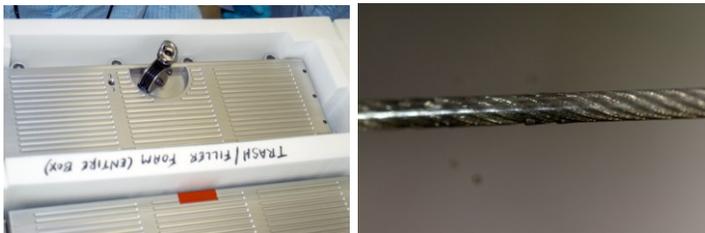
Figure 14. Damaged TVIS SLD cable and fleeting pulley design

The first set of SLDs went into service with the rest of the system in November 2000. On July 30, 2001, the crew reported that the SLD cable nylon sheath had worn away from the wire rope portion of the cable, causing the cable to jam. The root cause was determined to be off-axis cable loading and cable sheath abrasion due to TVIS exercise without the crew using SPDs. Passive exercise caused the subject to lean forward to manually drive the treadmill belt. As an interim workaround, the crew installed the SLD eyebolts and used SBSs for loading as a contingency. New SLDs were flown and installed in December 2001. In March

2002 the crew reported scraping noises coming from the second set of SLDs and noted asymmetric loading between the SLDs. These were removed from service, and again, the SBSs became the backup loading mechanism. A post-flight inspection revealed that exit pulley bearings and load cell pulley bearings had failed. This damage was caused when the SLD cable jumped off of the exit pulley during passive exercise on the TVIS System, again without the crew using SPDs. The bearings were not able to handle the off-axis loads and failed prematurely. In September 2006 the left SLD of the third set of SLDs installed on ISS experienced a failure

where the cable end stop detached from the SLD cable during exercise. The cable end stop remained attached to the crewmember's harness, and the free end of the cable retracted into the SLD housing. Visual inspection determined that the wire rope had separated from the ball shank termination that was swaged to it. Suspected causes were failure due to an improper crimp or a material defect, but the failed components were lost in transit from ISS to JSC, so no ground analysis was performed. Additionally, the post-fabrication verification pull test records could not be found by the external vendor. As a result the SLD drawing was updated to include a mandatory inspection point for the post-swage pull test, and all subsequent SLD cable swages were inspected using X-rays to verify proper crimping. A series of redesign efforts and life cycles tests were performed between 2003 and 2009, and changes were made to the SLD design to increase the pulley size, update the bearings, and add a rotating and fleeting exit pulley to prevent off-axis loading of the bearings. A final redesigned SLD was installed on orbit April 23, 2009, and the failures did not reoccur. Figure 14 shows a damaged TVIS SLD cable and the new fleeting pulley design [16,17,18].

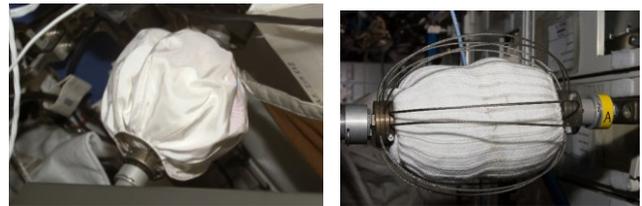
Figure 15. CEVIS isolators on ISS

CEVIS Isolators—The CEVIS isolators are wire rope egg-beater type devices that provide the only structural attachment between the CEVIS frame assembly and the ISS US Lab rack using seat track adapters. They contain 12 strands of 1/16 inch wire rope without sheathing, and an isolator assembly is attached at each of the four corners of the CEVIS frame to minimize the vibrations transmitted from the CEVIS system to the ISS structure during operation. The isolators were not initially assigned a limited life, and they are changed out on an as-needed basis when more than 8 out of 12 wire ropes are severed in a single isolator. The isolators are inspected every 3 months and have had a service life varying from 1 to 3 years. CEVIS isolators used on ISS are shown in Figure 15 [3].

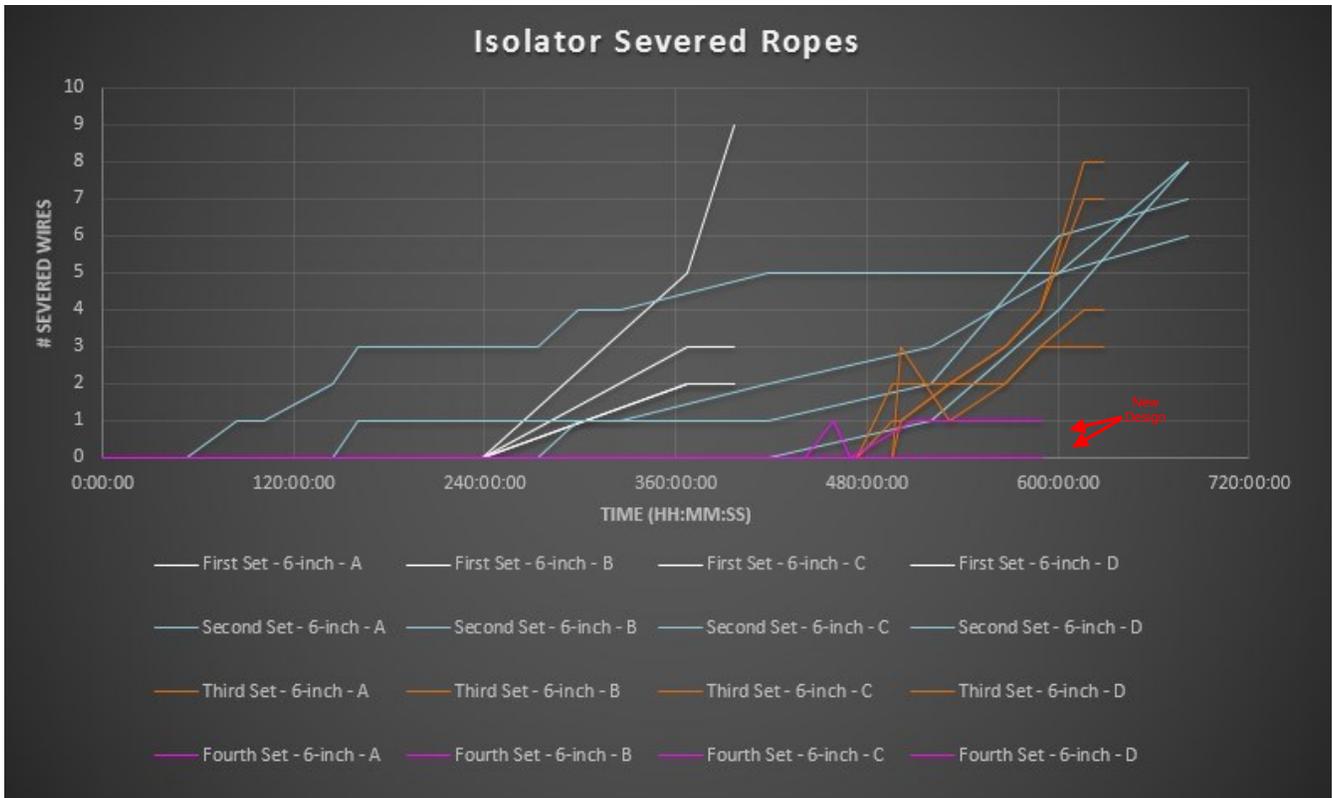
Figure 16. Service life of isolators.

Over the service life of CEVIS, inspections are conducted every 3 months to check the status of the isolators. The wire ropes have periodically broken due to fatigue at the clamp point, as a stress concentration exists at that point when the wire ropes are flexed, but they can remain in service if eight or less wires are severed. Once the eighth wire breaks, the unit is replaced. The crew on Expedition 6 added rolled sock-balls inside the wire cage to help reduce movement during the EVA exercise pre-breathe activity, which purges the body of nitrogen before a spacewalk is conducted. This requires rigorous pedaling and movement with the arms, which makes the CEVIS riding very unstable without the socks. They also act as bump stops and prevent severe bending of the wire ropes.

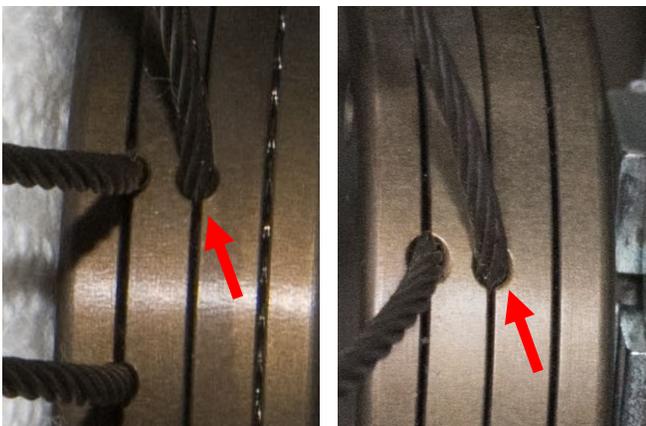
Old design with no chamfer (left); new design with chamfer (right)

Figure 17. Whole edges where wire ropes pass through clamp plates.

The clamp plates of the CEVIS isolator were redesigned in 2011 to add a chamfer to the edge of the hole where the wire rope passes through the plates, thus reducing the stress concentration at that point. This small change has increased service life of the isolators substantially, and the true service life is still being evaluated, as only one wire has failed on one isolator in almost 4 years of use. Figure 16 shows the results of a trending spreadsheet tool that documents the number of severed wire ropes of a given set of CEVIS isolators versus time of service. The graph clearly shows that the new design (magenta lines) is a dramatic improvement [19]. Figure 17 shows the before and after pictures of the CEVIS isolator design change.

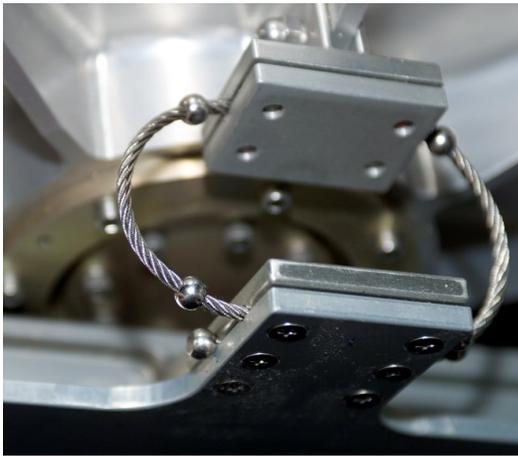
Figure 18. TVIS gyroscope wire ropes

TVIS Gyroscope Wire Rope—The TVIS Gyroscope Assembly is used to stabilize the TVIS System from excessive roll motion during operation and provides current peak smoothing of the TVIS System power sources. The Gyroscope has a vertical spin axis and pivot bearings positioned in the pitch direction to allow for the required precession during operation. The TVIS gyroscope incorporated two (one per side) 1/8 inch swaged wire rope assemblies that aided in restoring the gyroscope back to its neutral position and prevented excessive movement. The

thought was that the wire ropes would act as a spring and dampen out extreme motion before the gyroscope pivots hit the hard stops. The gyroscope wire rope originally was not assigned a limited life, and no spares were launched, but after failures on orbit, a certified operational life of at least 250 hours was derived based on historical data and maintenance inspections. This equated to approximately 9 months with three crewmember use. The wire ropes were required to be changed out, at a minimum, every year. In the event that the gyroscope wire ropes were severed, gyroscope motion increased, resulting in contact with the gyroscope blue rubber bumpers, which acted as the secondary damping system. Once wire rope damage was identified, both wire ropes were replaced prior to resuming TVIS System operations. Figure 18 shows the TVIS gyroscope wire ropes as configured for ISS use [2].

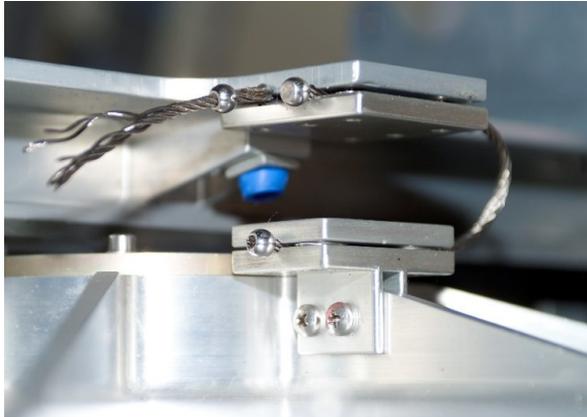
Figure 19. Failed TVIS gyroscope wire rope

Unexpected damage to the gyroscope wire ropes was first observed in a TVIS treadmill removal and replacement activity in October 2002, about 2 years after TVIS was first operated. Root cause was determined to be a combination of incorrect installation of the clamping plate, which pinched the ropes, and cyclic fatigue due to stress concentrations at the clamp plate. This established a new requirement for a 1-year limited life on the wire ropes. New wire ropes were launched to ISS to replace the damaged ropes, and they were subsequently replaced every year as a maintenance activity. Figure 19 shows a failure of a TVIS gyroscope wire rope [20].

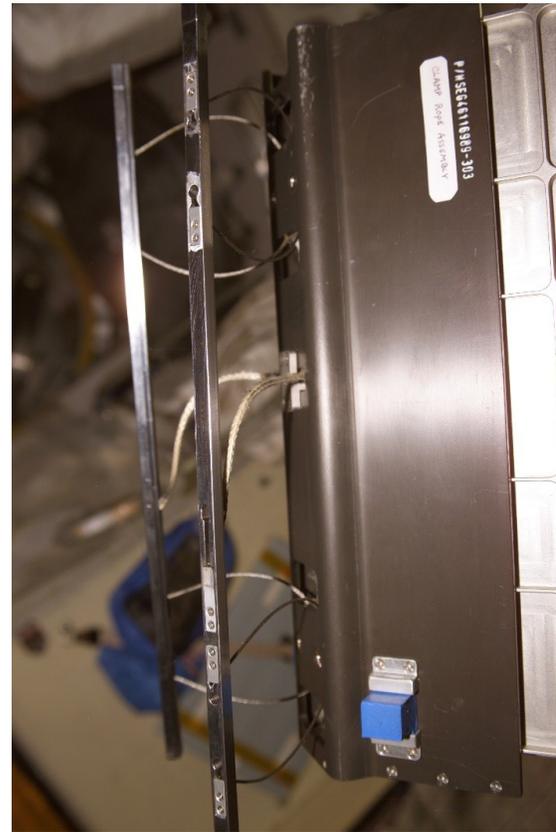
Figure 20. TVIS stabilizer corner bracket assembly including wire ropes

TVIS Stabilizer Wire Ropes—The TVIS stabilizer wire ropes centered the TVIS System in the SM pit, provided an attachment point to the SM structure, and isolated forces from being transmitted to the ISS. Each corner assembly contained one textile Kevlar® (later Vectran) stabilizer protection tether and four 1/16 inch steel wire ropes to limit the travel of the movement within the pit. The wire ropes were attached to the TVIS stabilizers via a terminal ball-swage inserted into a slot with a fastened cover plate to retain them. They were mounted on the opposite end in a similar fashion to rails that mounted to the corners of the SM pit. Figure 20 provides a photograph of the TVIS stabilizer corner bracket assembly including the wire ropes.

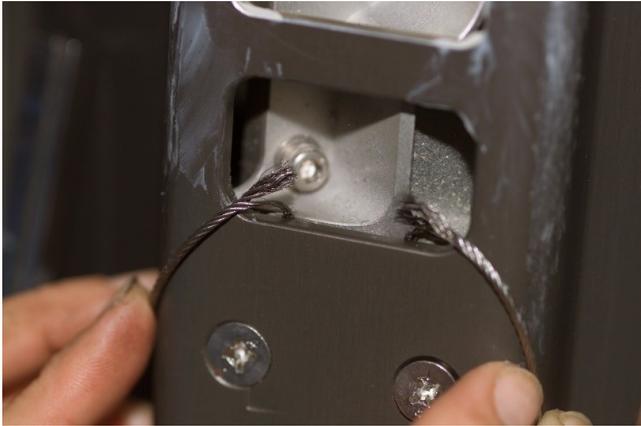
Figure 21. Failed TVIS stabilizer corner wire rope

The steel wire ropes and Kevlar over-travel protection ropes did not originally have a limited life assigned to them and no spares were stored on-orbit. Damage observed by the crew on Expedition 1 in February 2001 due to the Kevlar stabilizer protection tether severing highlighted the need for maintenance on the ropes. The protection ropes were originally made of Kevlar, but their load rating was below the applied forces on orbit. After a short ground evaluation, the Kevlar design was replaced with Vectran, which had five to six times the break strength of the Kevlar rope, replacements were launched to ISS, and the failure was never observed again. During the same call-down as the Kevlar rope severing, the crew reported that multiple stabilizer wire ropes were damaged or severed. The subsequent investigation concluded that the failure could be contributed to three causes. First, the failure of the Kevlar over-travel protection rope allowed the wire ropes to become taut and experience the full load of the treadmill chassis pulling on them. Second, it was determined that excessive clamp force between the rope clamp assembly and the stabilizer interface deformed the wire rope, causing premature fatigue. Third, the sharp bend radius imposed on the wire rope also caused the failure at the point of greatest cycling fatigue. As a result, spares were launched to ISS, the damaged wires were replaced, and spares were maintained onboard for the duration of the remaining TVIS service. The TVIS stabilizer corner bracket assemblies were inspected monthly and the wire ropes were replaced when at least half were severed. A redesign was a possibility, but the ISS Program chose to resupply the ropes

and change them out periodically when damage was observed. After the Vectran over-travel protection rope was installed, stabilizer wire ropes typically lasted ~3 years between change-outs. A failed TVIS stabilizer corner wire rope is shown in Figure 21 [21,22].

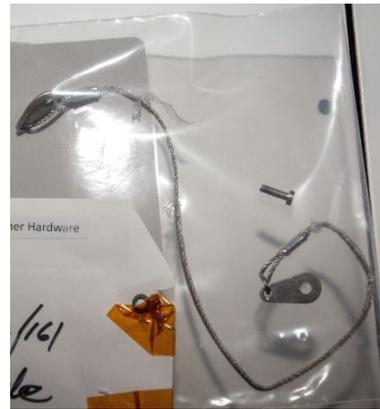
Figure 22. Damaged ARED VIS PIP pin tether

VIS PIP Pin—Crew reports in 2012 indicated that the VIS PIP pin tethers had frayed Teflon sheaths, but the crew did not think the damage required tape to protect them from sharp frayed wire strands. The root cause could not be determined, but the most likely cause was the tethers being pinched between the pin and the VIS outer plate due to the pins not being temporarily stowed in the provided stowage slots when not inserted into the VIS. This would allow the pin to float and become pinched during ARED exercise. The crew was trained to temporarily stow the pins when not inserted, and spare tethers are on-board the ISS in case replacement is required. Figure 22 shows a damaged ARED VIS PIP pin tether [24].

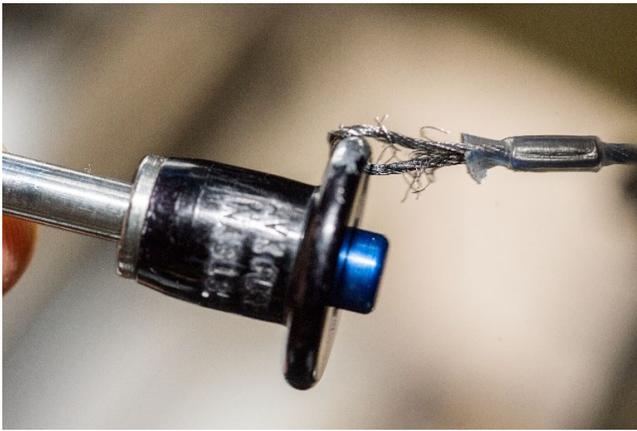
Figure 23. Damaged ARED hard stop pin tether

ARED Hard Stop Pins (Heel Raise Pins)—Crew reports in 2013 indicated that the ARED hard stop PIP pin tethers had frayed Teflon sheaths and wire. The crew was instructed to wrap the tethers with tape to protect them from contacting sharp, frayed wire strands with their hands. The root cause could not be determined, but the most likely cause was the tethers being pinched between the hard stop mechanism and upper stop plate. This can occur when the pins are not temporarily stowed in the provided stowage holes when removed from the upper stop mechanism. This allows the pin to float and become pinched during ARED exercise. The crew was trained to temporarily stow the pins when not inserted, and spare tethers are on board the ISS in case replacement is required [25]. Figure 23 shows a damaged ARED hard stop pin tether.
